Pentagon Protection USA

Shock Tube Testing for Window Systems

September 2008
San Antonio, Texas

ABS Consulting Project Number 1865120

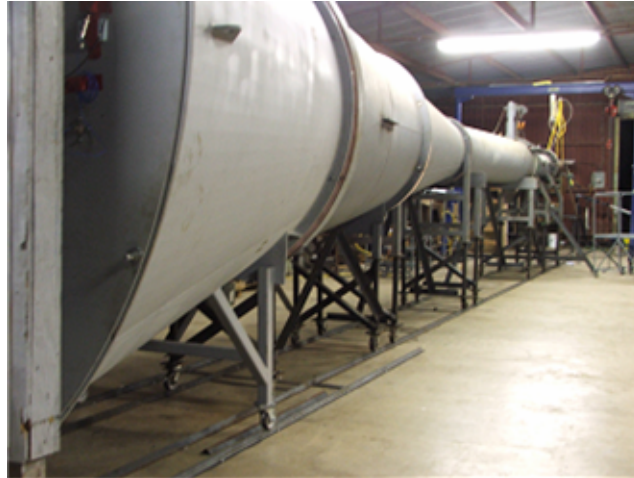
Figure 1. ABS Consulting Shock Tube Apparatus

Blast loads were applied using a “shock tube” as shown in Figure 1. This device uses a sudden burst of compressed air to create a blast pulse, which travels down the tube and is applied to the test specimen which is secured to the end of the tube. An enclosure (test cubicle) is attached to the end of the tube. The blast load creates a specified positive blast pressure and impulse on the test specimens. Testing was conducted with blast loads designed to meet the various threat – standoff combinations as described in the UFC and ISC Security Design Criteria.

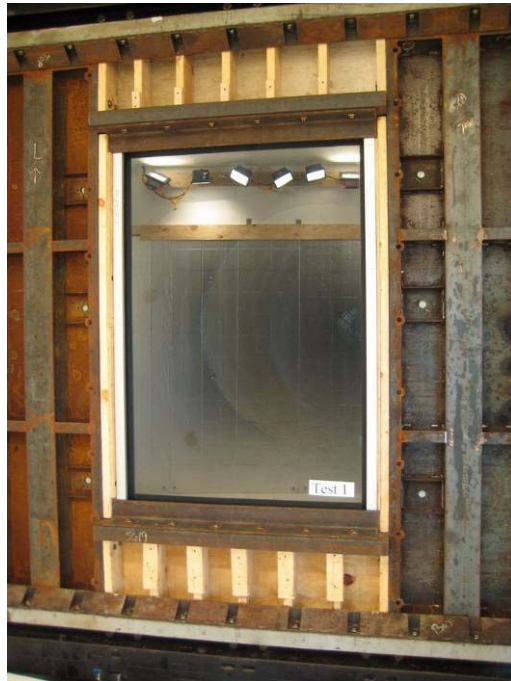
Figure 2. Window Mounted in Test Fixture

Window frame assemblies were rigidly supported along the top and bottom simulating windows attached at the head and sill. Window anchorage and attachment to the wall substructure was not evaluated in the testing. Steel angle and plate were used to support the framing to prevent translation. This configuration simulates a properly anchored window system installed in the field. Figure 2 shows a typical window mounted in the ABS test sub-frame affixed to the test enclosure. A close-up view of the window mounted in the sub-frame is shown in Figure 3. In order to fit the opening of the sub-frame (48-inches by 70-inches), the window frame was shimmed with wood.

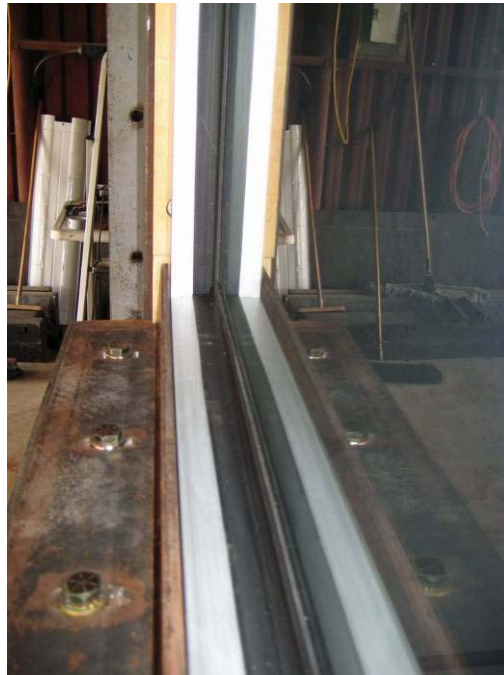
Figure 3. Close-up View of Mounting

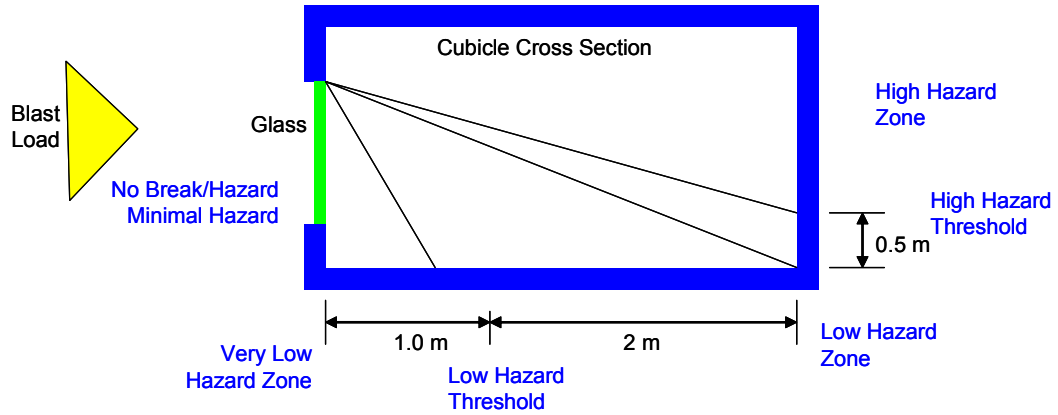
Figure 5. ASTM F1642-04 Performance Criteria

Fragments striking and embedding in the witness panel were collected and documented. Performance conditions for each test item were assigned and recorded in accordance with ASTM F1642-04 and the GSA criteria as shown in Figure 5 and Figure 6, respectively.
